Chautauqua Lake

Third-Party Monitoring for Chautauqua Lake Macrophyte
Management: Herbicide Program

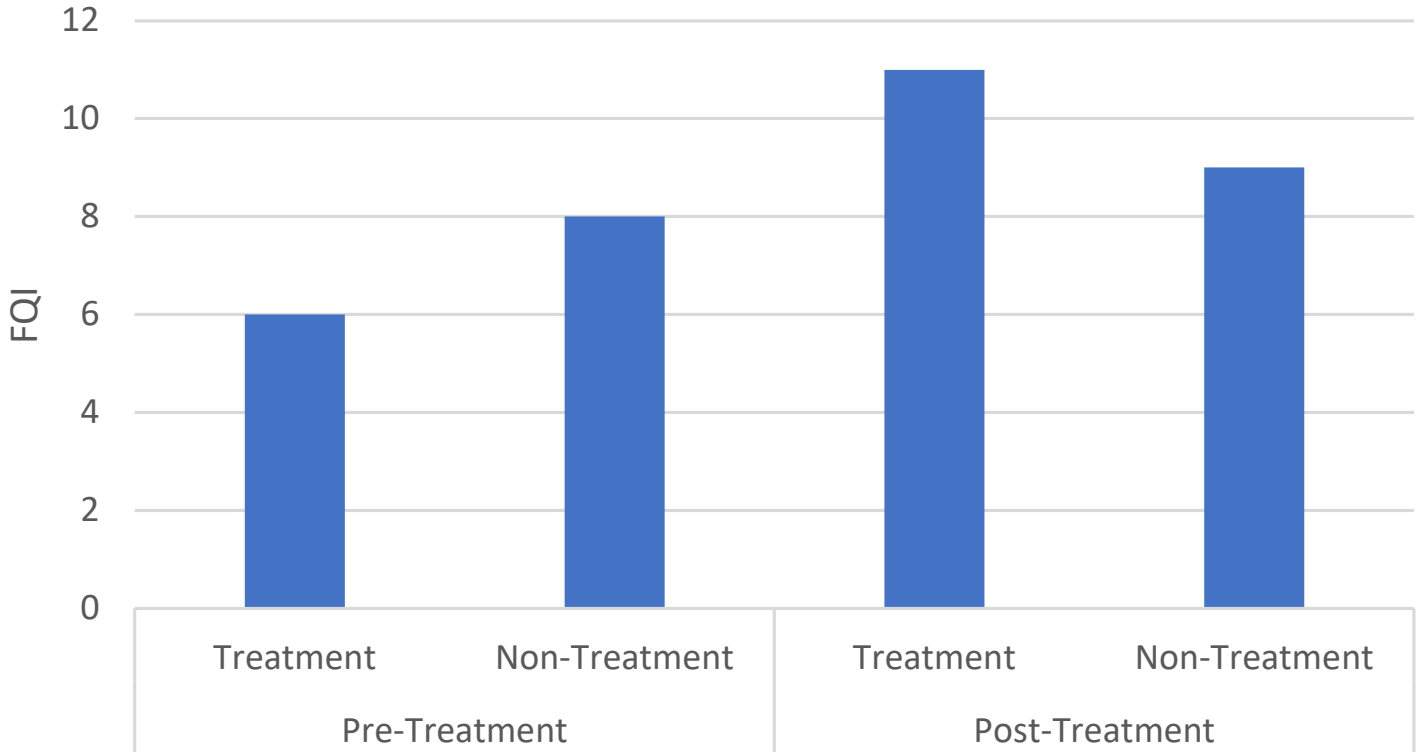
Chautauqua Lake - Floristic Quality Index

- Standardized assessment method that calculates a numerical index reflecting the quality of a native plant community in a given area (Conservationtools.org)
- Computed utilizing a species list and an applied Coefficient of Conservation (C) for each species
- C-values selected for this project were derived from the database associated with the Mid-Atlantic Allegheny Plateau (glaciated) (2012) as accessed via universalfqa.org.
