Chautauqua Lake SAV Survey Results Fall 2023

Figures and Tables

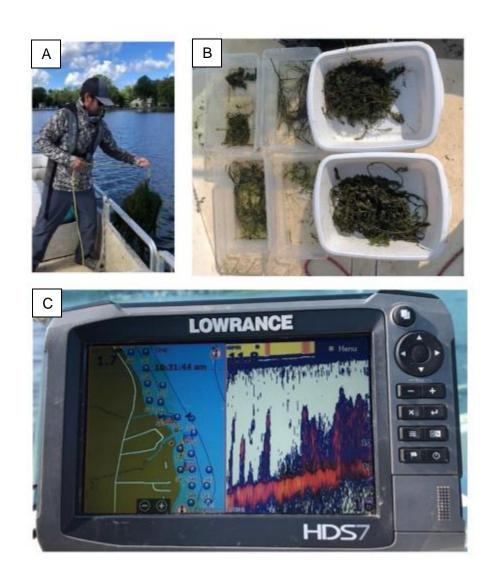
Figure 1: Retrieving and sorting SAV by species (A;B) while concurrently recording sonar/SAV biovolume data throughout the littoral zone of Chautauqua Lake (C).

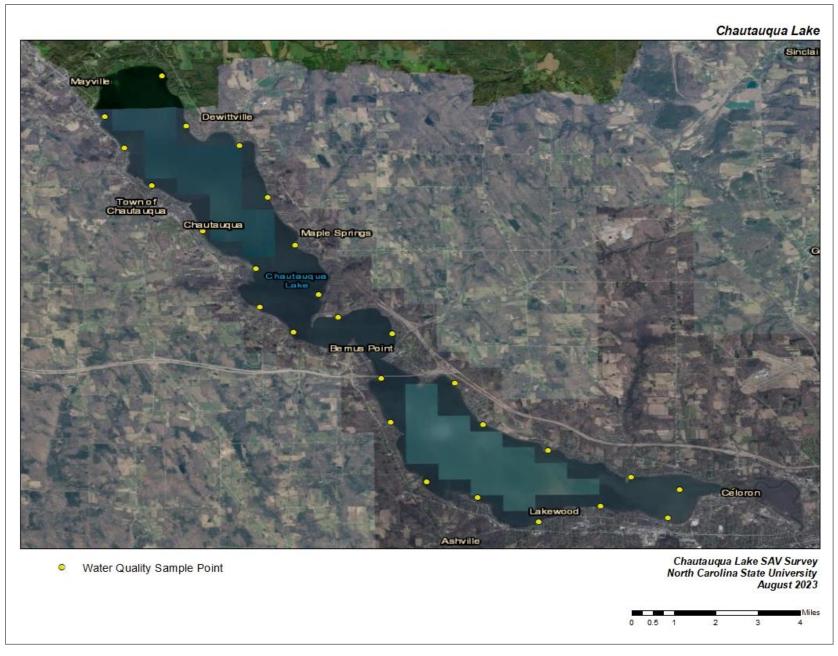
Figure 2: Water quality sample sites during the Fall 2023 survey.

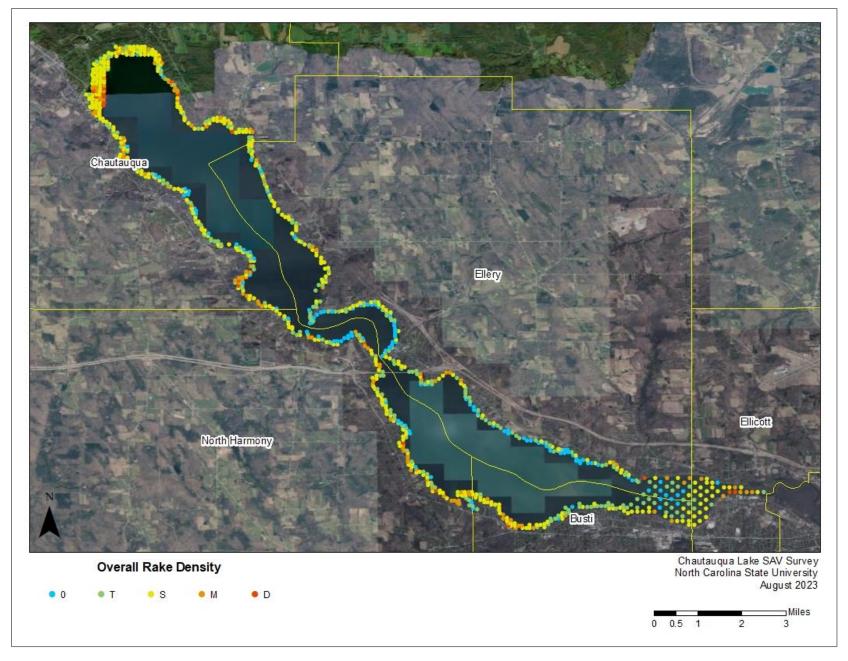
Figure 3: Overall rake density of surveyed points during Fall 2023 SAV Survey at Chautauqua Lake. '0': No SAV; 'T': Trace SAV; 'S': Sparse SAV; 'M': Moderate SAV; 'D': Dense SAV

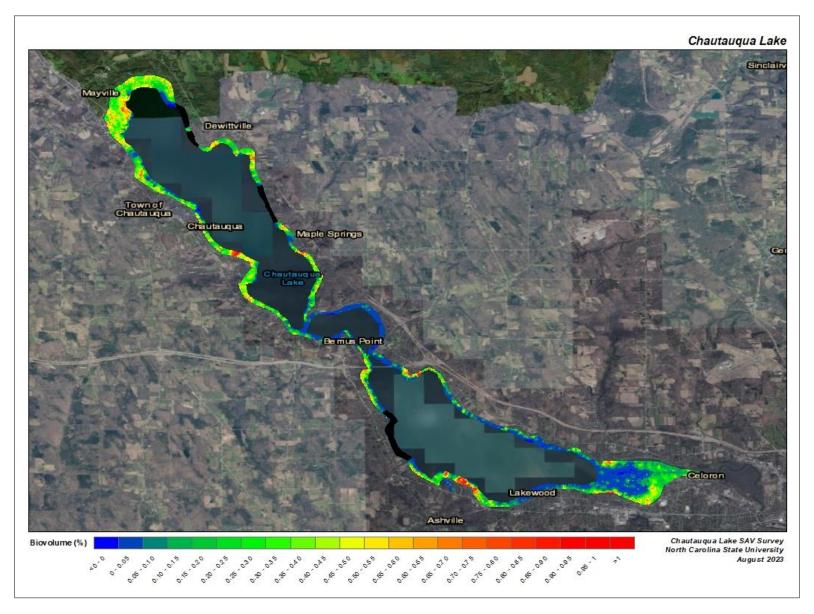
Figure 4: Lake-wide SAV biovolume estimates constructed from echosounding data. Warmer color areas represent greater water column occupancy (0-100% occupied). Regions marked black contained inconclusive data likely due to windy weather conditions during time of survey.

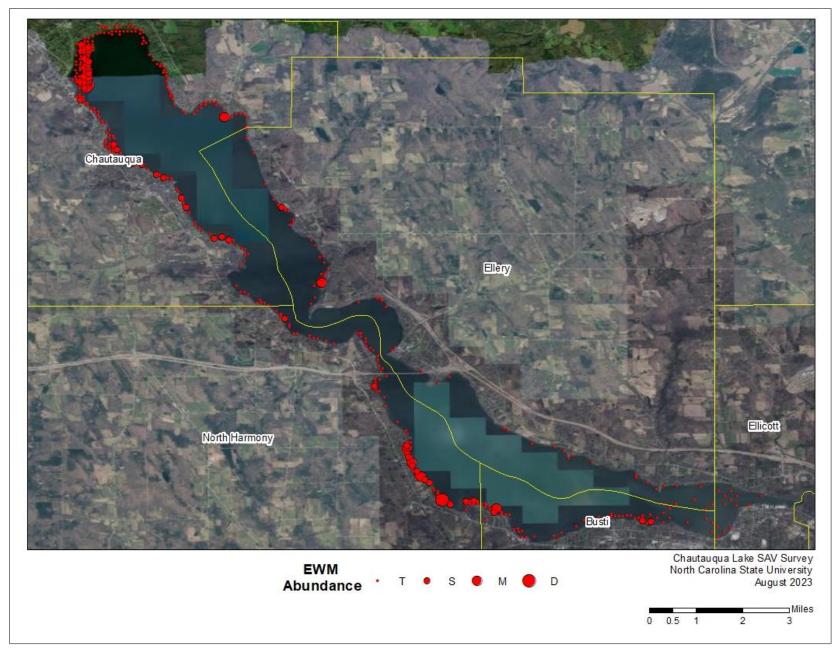
Figure 5: Distribution and abundance of Eurasian watermilfoil (EWM) in Chautauqua Lake during Fall 2023 SAV survey. 'T': Trace EWM; 'S': Sparse EWM; 'M': Moderate EWM; 'D': Dense EWM

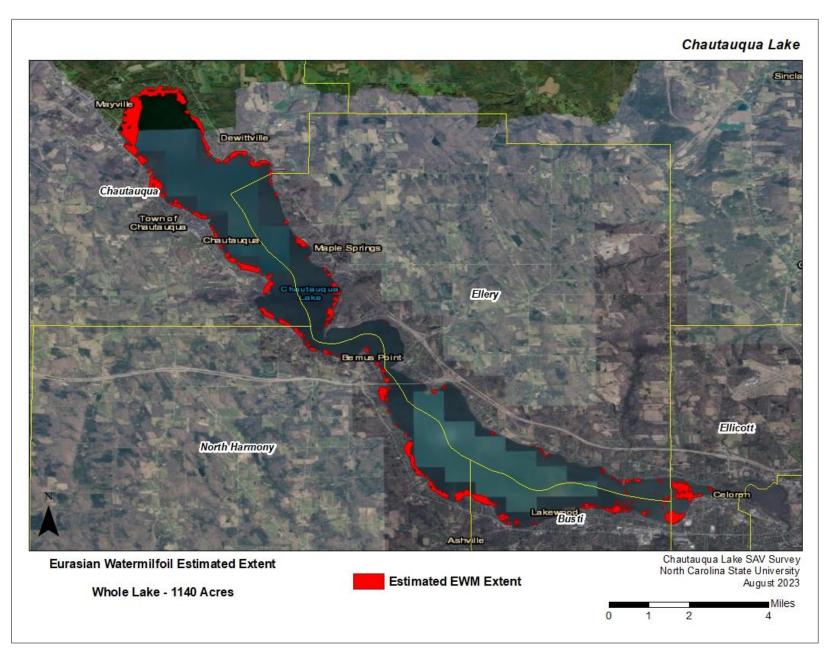
Figure 6: Interpolated estimate of Eurasian watermilfoil (EWM) found throughout Chautauqua Lake.

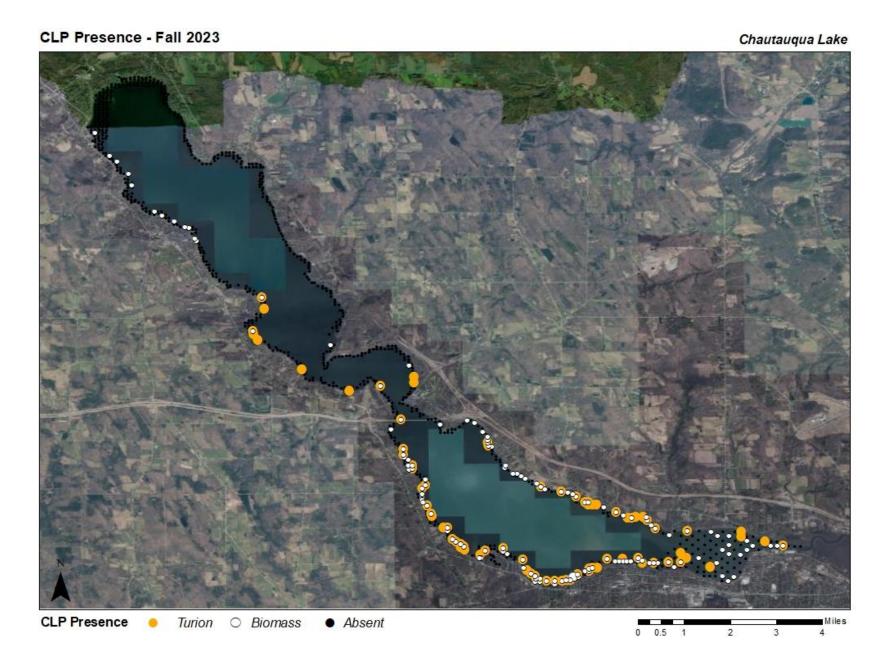
Figure 7: Distribution of curly-leaf pondweed (CLP; Potamogeton crispus) biomass and turions during the Fall 2023 survey.

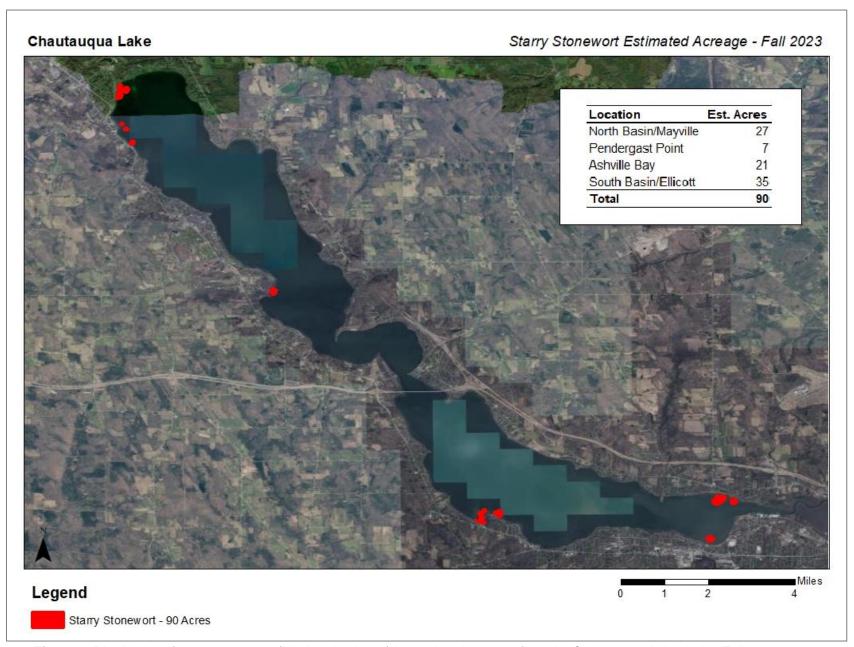
Figure 8: Distribution of starry stonewort (Nitellopsis obtusa) interpolated acreage from the Chautauqua Lake during Fall 2023 survey.

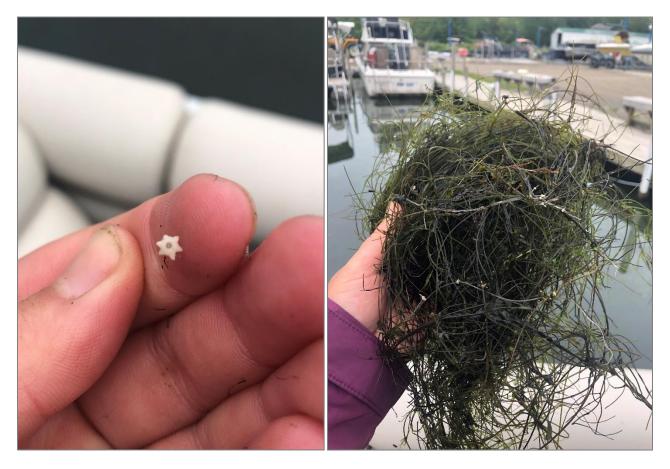
Figure 9: Example of starry stonewort (Nitellopsis obtusa) bulbil (left) and biomass (right) documented during the Fall 2023 survey.

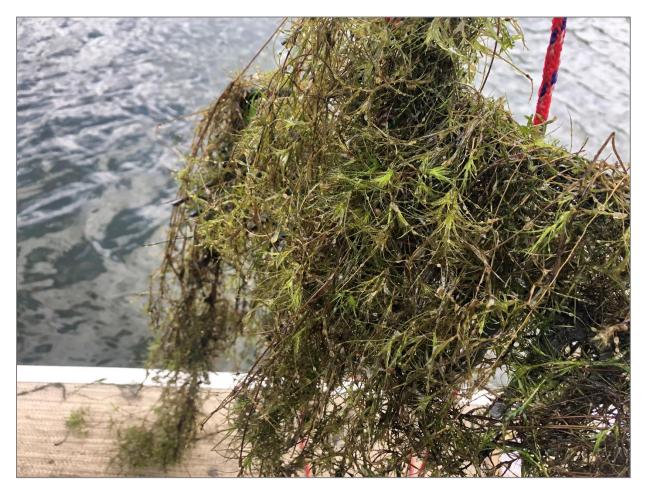
Figure 10: Example of dense brittle naiad (Najas minor) biomass documented during the Fall 2023 survey.

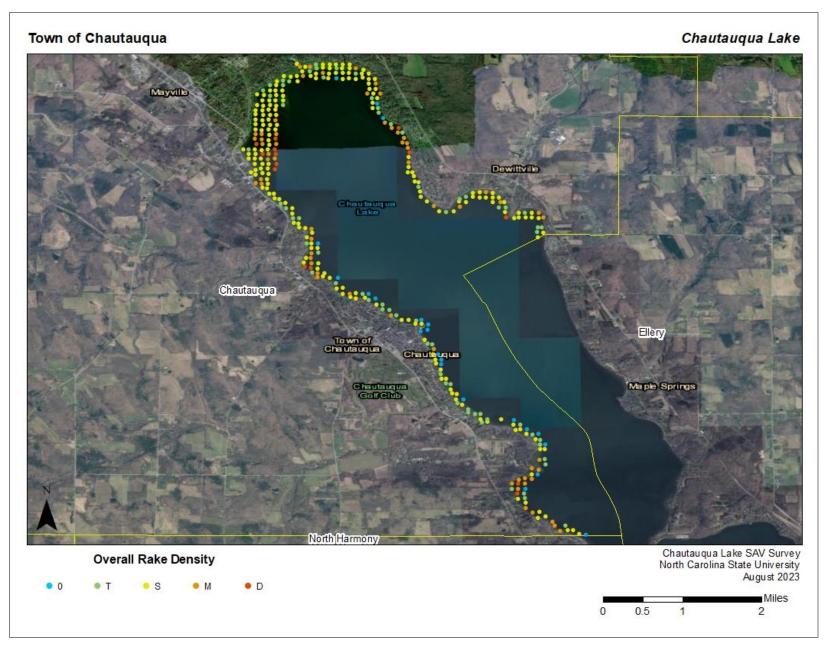
Figure 11: Overall rake density of surveyed points in the Town of Chautauqua during Fall 2023 SAV Survey at Chautauqua Lake. '0': No SAV; 'T': Trace SAV; 'S': Sparse SAV; 'M': Moderate SAV; 'D': Dense SAV

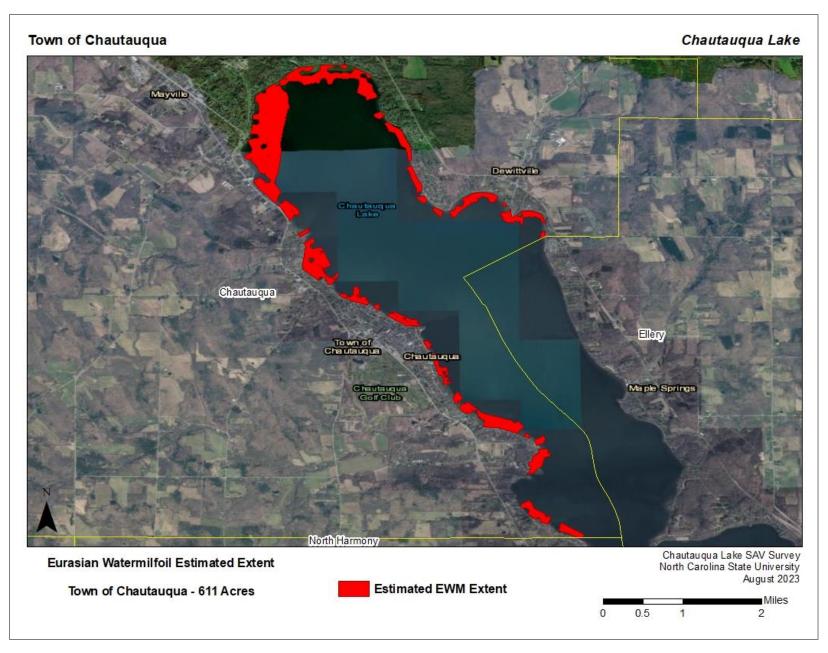
Figure 12: Interpolated estimates of Eurasian watermilfoil (EWM) distribution within the Town of Chautauqua

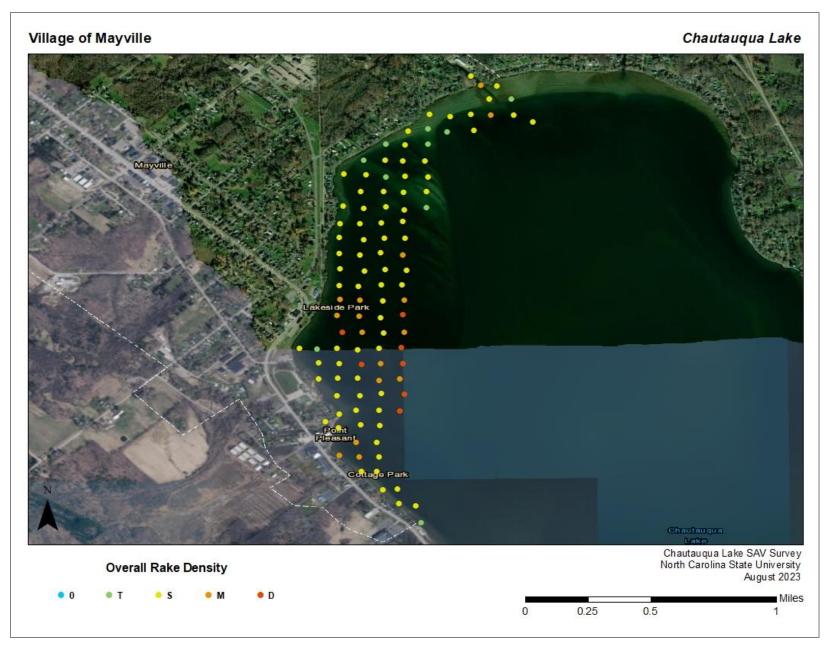
Figure 13: Overall rake density of surveyed points in the Village of Mayville during Fall 2023 SAV Survey at Chautauqua Lake. '0': No SAV; 'T': Trace SAV; 'S': Sparse SAV; 'M': Moderate SAV; 'D': Dense SAV

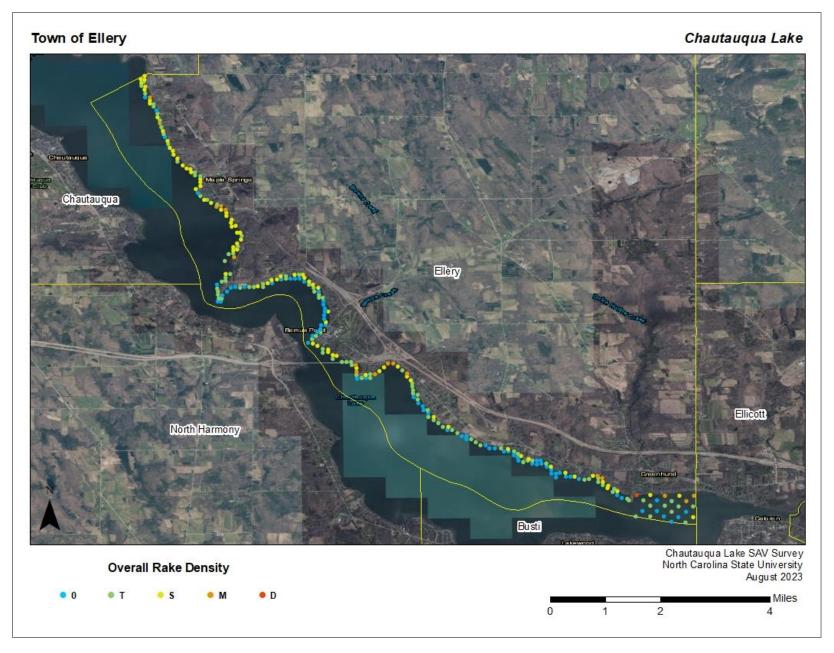
Figure 14: Overall rake density of surveyed points in the Town of Ellery during Fall 2023 SAV Survey at Chautauqua Lake. '0': No SAV; 'T': Trace SAV; 'S': Sparse SAV; 'M': Moderate SAV; 'D': Dense SAV

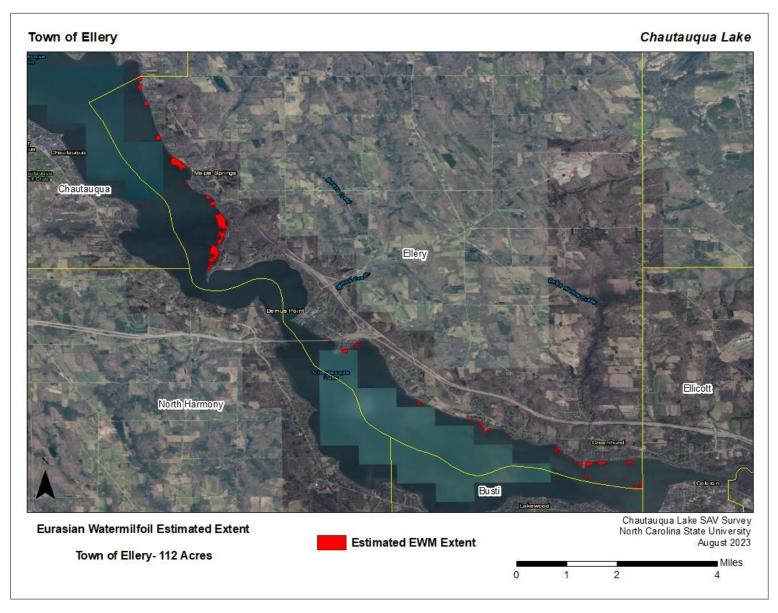
Figure 15: Interpolated estimates of Eurasian watermilfoil (EWM) distribution within the Town of Ellery

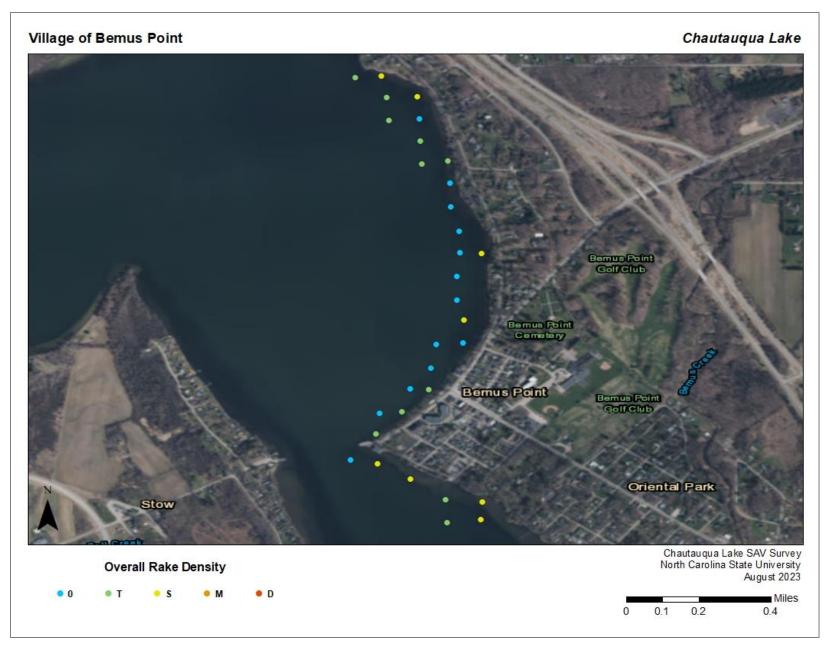
Figure 16: Overall rake density of surveyed points in the Village of Bemus Point during Fall 2023 SAV Survey at Chautauqua Lake. '0': No SAV; 'T': Trace SAV; 'S': Sparse SAV; 'M': Moderate SAV; 'D': Dense SAV

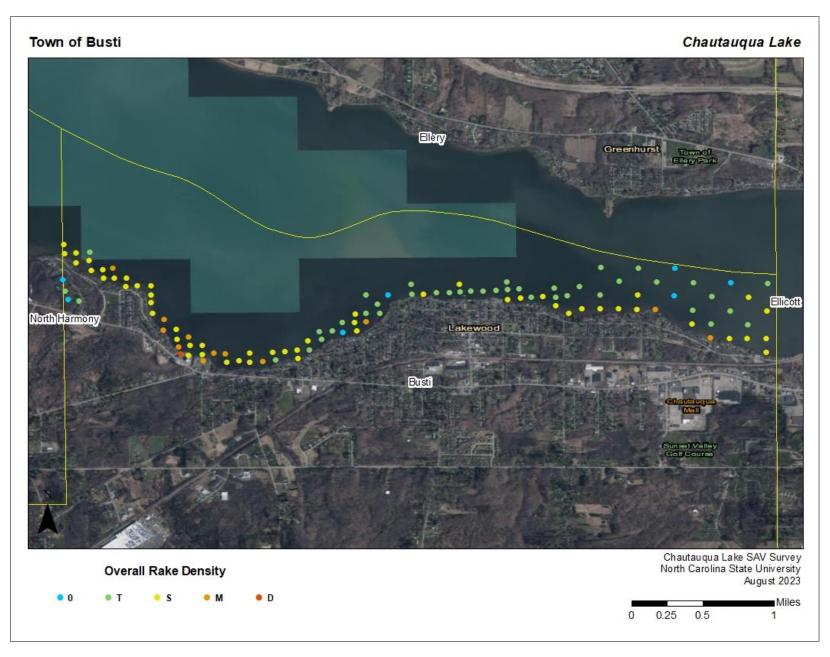
Figure 17: Overall rake density of surveyed points in the Town of Busti during Fall 2023 SAV Survey at Chautauqua Lake. '0': No SAV; 'T': Trace SAV; 'S': Sparse SAV; 'M': Moderate SAV; 'D': Dense SAV

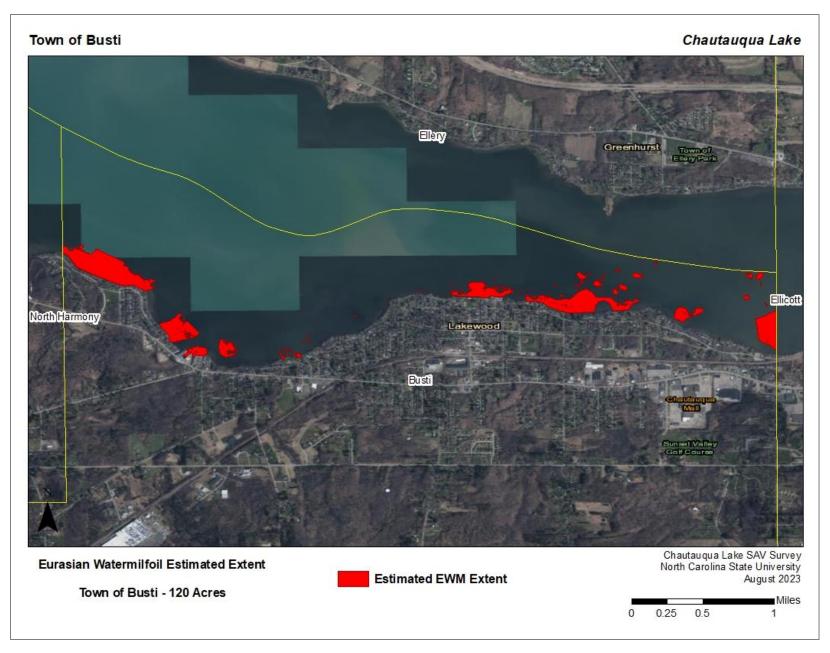
Figure 18: Interpolated estimates of Eurasian watermilfoil (EWM) distribution within the Town of Busti

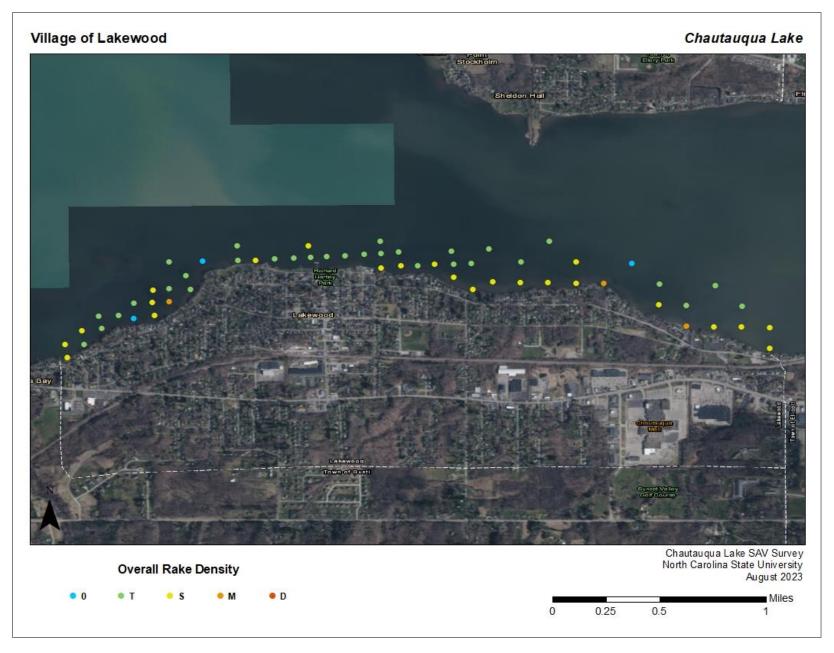
Figure 19: Overall rake density of surveyed points in the Village of Lakewood during Fall 2023 SAV Survey at Chautauqua Lake. '0': No SAV; 'T': Trace SAV; 'S': Sparse SAV; 'M': Moderate SAV; 'D': Dense SAV

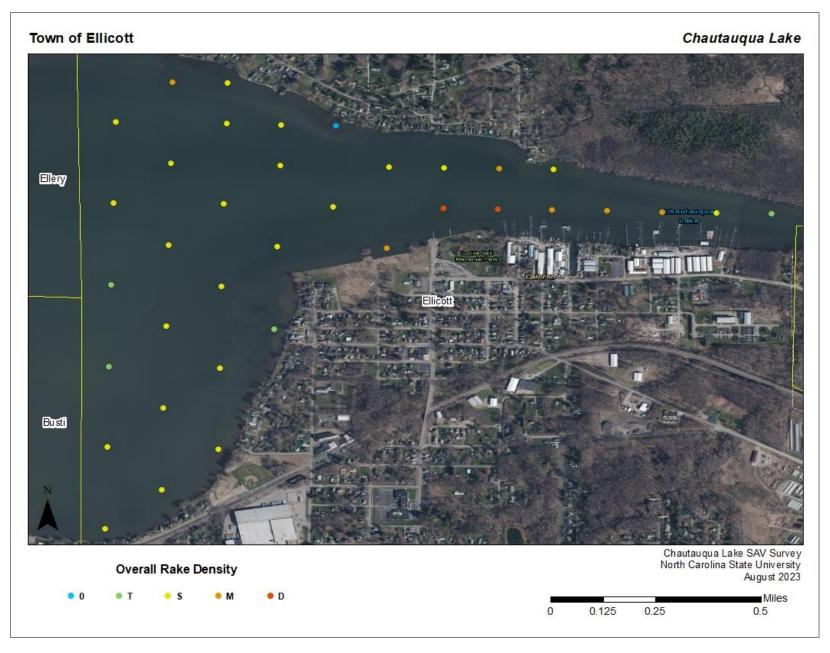
Figure 20: Overall rake density of surveyed points in the Town of Ellicott during Fall 2023 SAV Survey at Chautauqua Lake. '0': No SAV; 'T': Trace SAV; 'S': Sparse SAV; 'M': Moderate SAV; 'D': Dense SAV

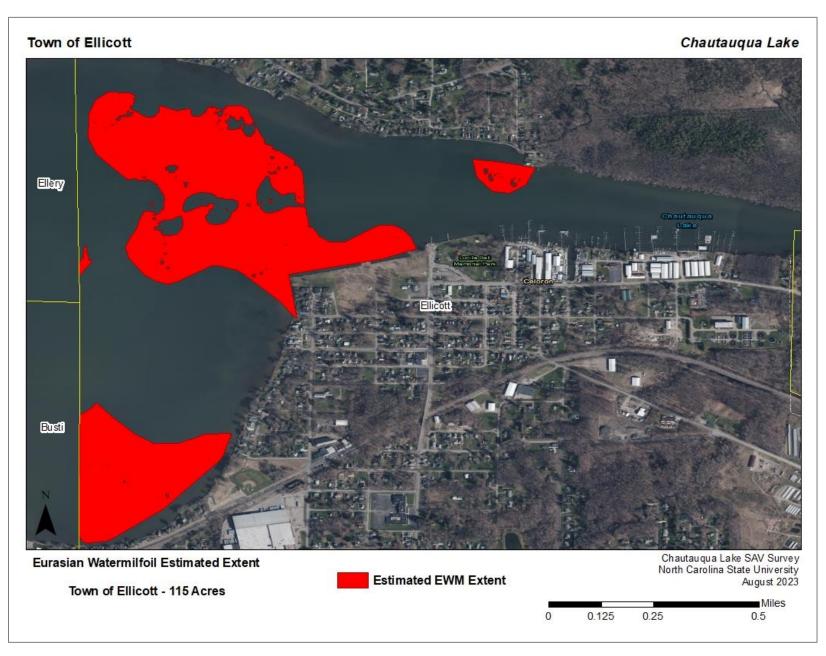
Figure 21: Interpolated estimates of Eurasian watermilfoil (EWM) distribution within the Town of Ellicott

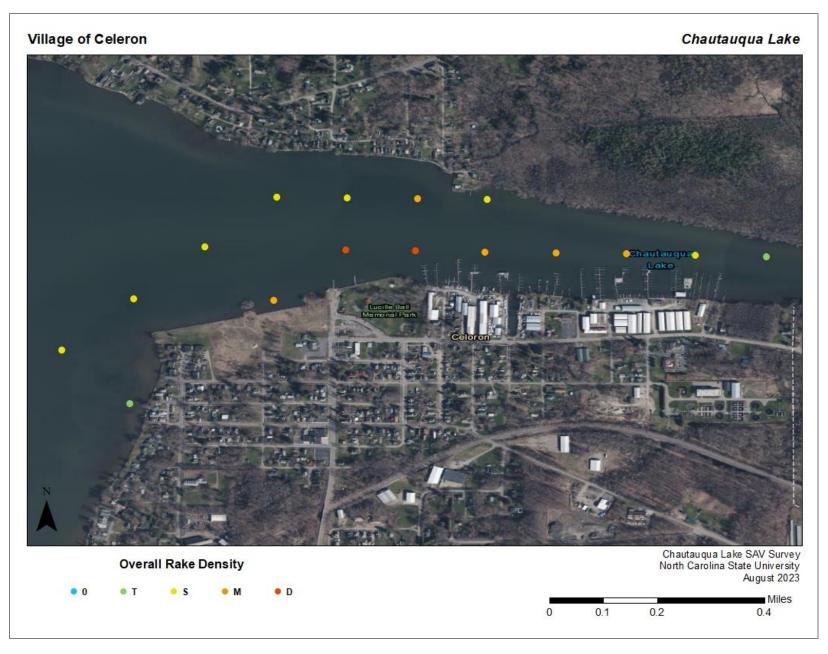
Figure 22: Overall rake density of surveyed points in the Village of Celeron during Fall 2023 SAV Survey at Chautauqua Lake. '0': No SAV; 'T': Trace SAV; 'S': Sparse SAV; 'M': Moderate SAV; 'D': Dense SAV

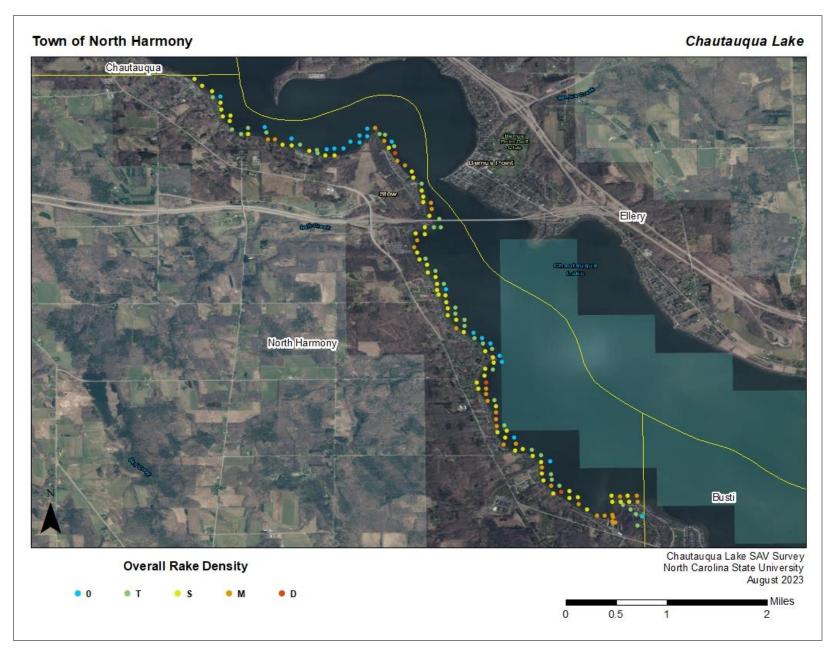
Figure 23: Overall rake density of surveyed points in the Town of North Harmony during Fall 2023 SAV Survey at Chautauqua Lake. '0': No SAV; 'T': Trace SAV; 'S': Sparse SAV; 'M': Moderate SAV; 'D': Dense SAV

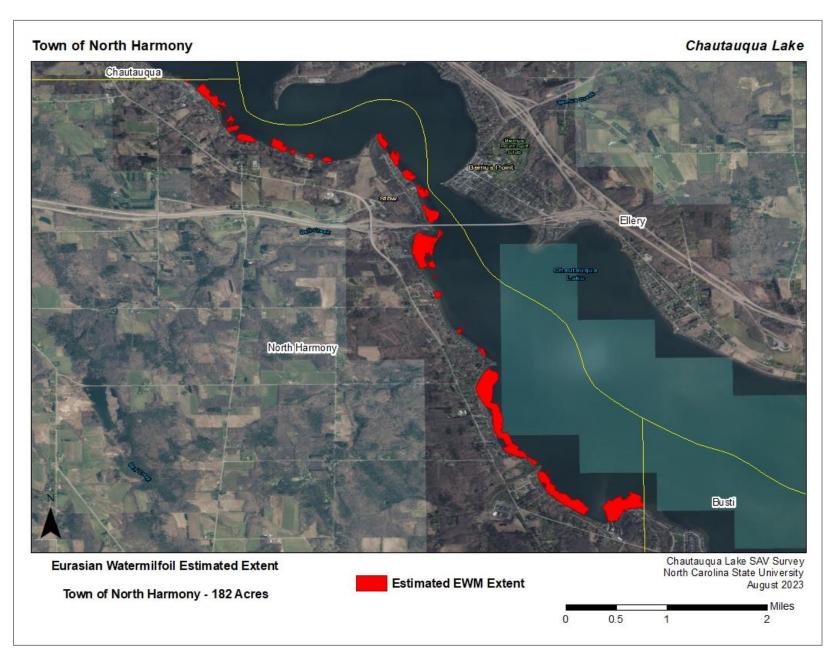
Figure 24: Interpolated estimates of Eurasian watermilfoil (EWM) distribution within the Town of North Harmony

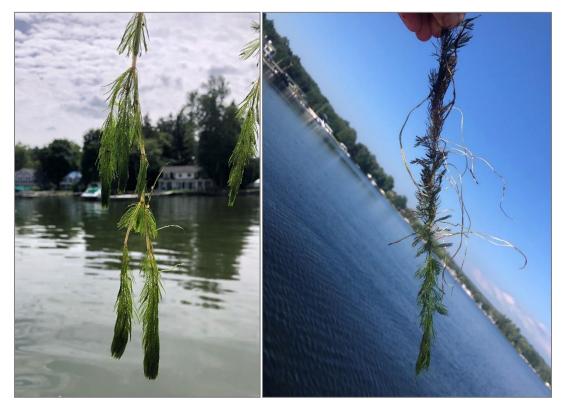
Figure 25: Examples of healthy Eurasian watermilfoil stems. Note the formation of adventitious roots (right) allowing fragments of this plant to recolonize new sites after fragmentation

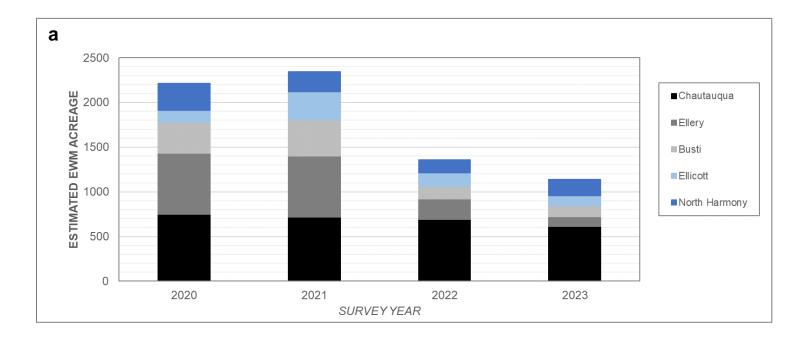
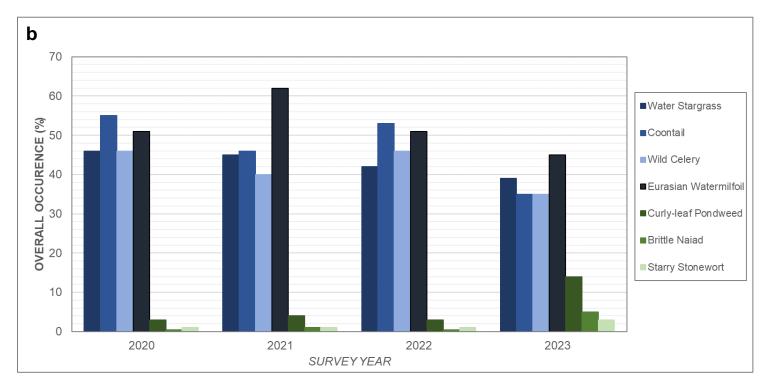
Figure 26: a: Estimated EWM acreage over time at Chautauqua Lake separated by Town, b: overall abundance (%) of SAV species at Chautauqua Lake at surveyed points over time

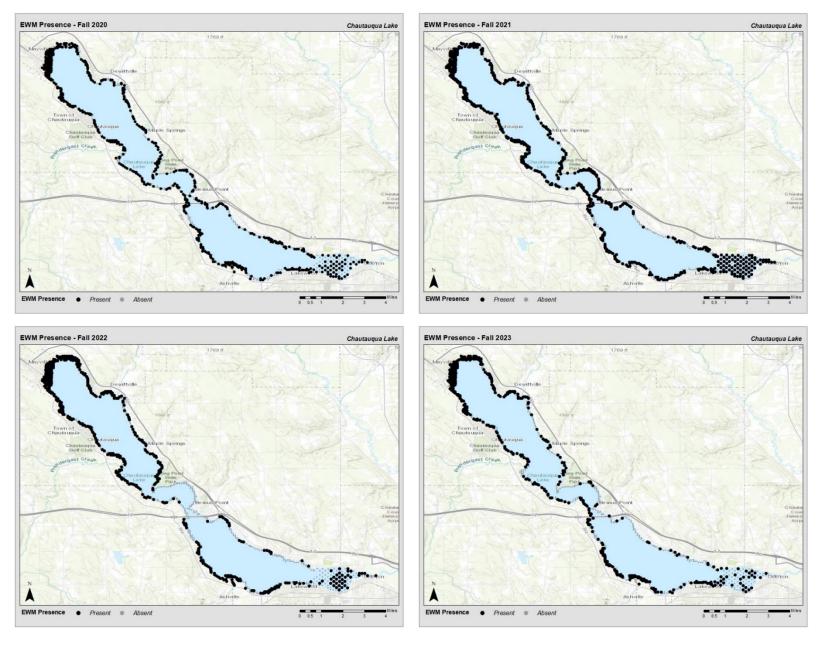
Figure 27: Presence of Eurasian watermilfoil (EWM) at survey points during Fall 2020 - Fall 2023 surveys.

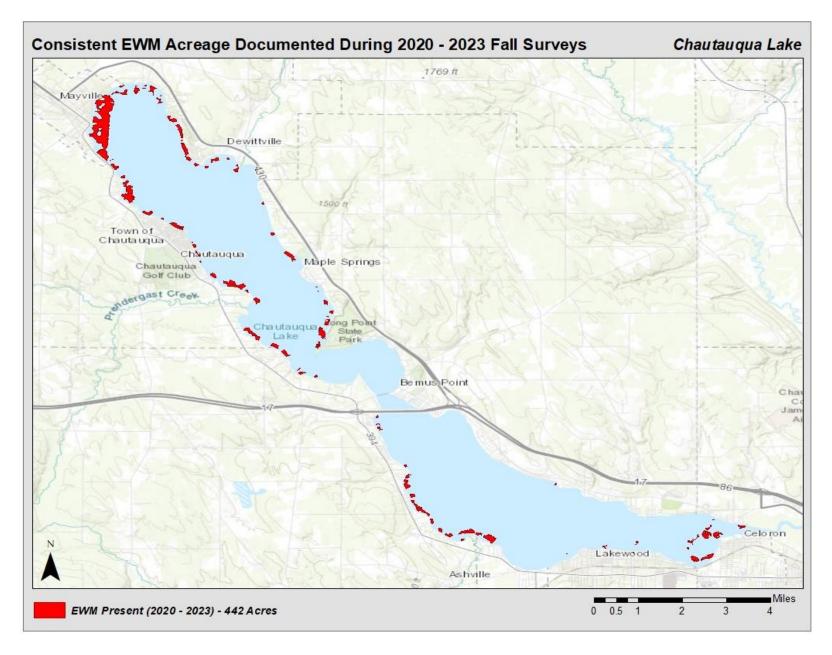
Figure 28: Areas of Chautauqua Lake where Eurasian watermilfoil (EWM) has been consistently delineated during 2020 – 2023 Fall surveys.

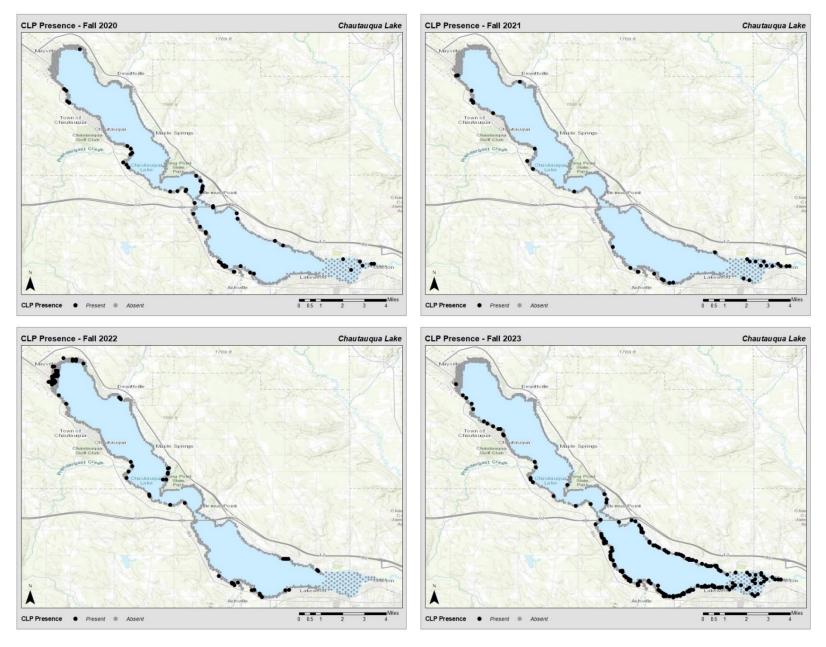
Figure 29: Presence of Curly-leaf pondweed (CLP) at survey points during Fall 2020 - Fall 2023 surveys.
