Chautauqua Current No. 4

Chautauqua Lake & Watershed Management Alliance, Inc. April 25, 2022

Watershed Moments

Projects Working Around the Clock to Protect Chautauqua Lake

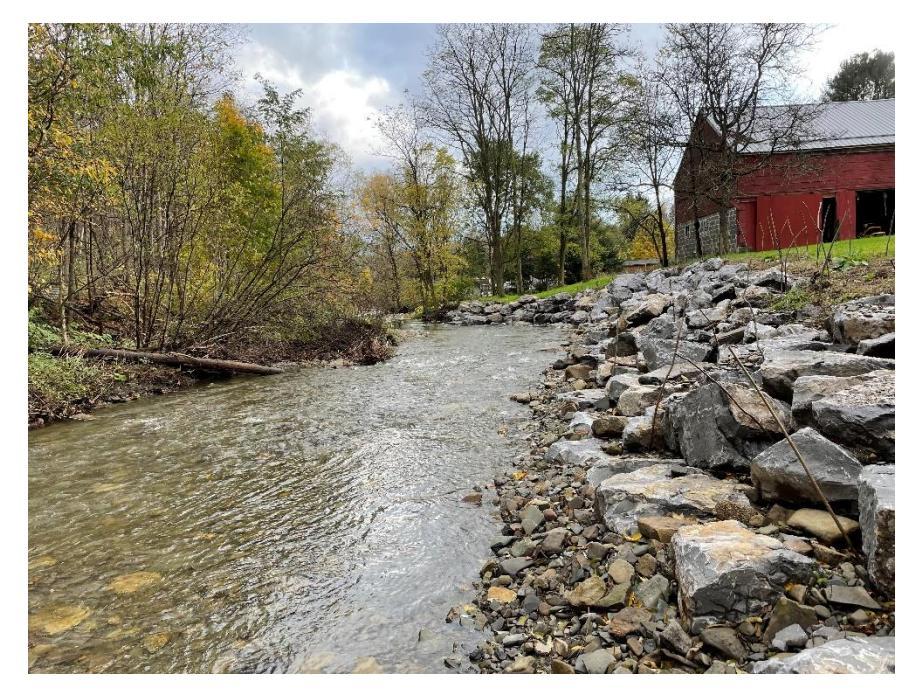
Figure 1. Pictured above is a recently stabilized section of Dutch Hollow Creek in the Town of Ellery, a project which was completed through the NYSDEC Water Quality Improvement Project program.

In the picture above, a newly armored section of Dutch Hollow Creek can be seen to the right of the frame. A previously eroded bank being stripped of sediment and encroaching on a nearby barn is now protected with rock and woody plants. These features will be at work improving water quality in the stream and lake for years and years to come, offering gradual improvements that add up to significant benefits in the long run. These projects were funded in part by the Environmental Protection Fund administered by the NYSDEC and by securing local matching funds, which were provided in part by the county's Occupancy Tax Program for these six grants. The projects stabilized approximately 5,000 linear feet of streambanks across five of Chautauqua Lake's major tributaries. The Chautauqua Watershed Conservancy (CWC) and the Chautauqua County Soil and Water Conservation District played vital roles in these projects.
